Manhole Inspection Summary

Manhole # S37C__007MH

Insp Date: **8/22/08 8:48 AM**

Location Address: **224 n front st**

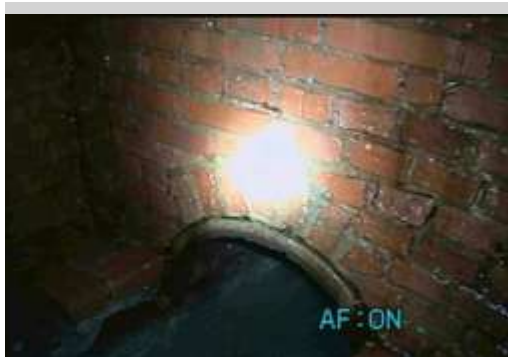
Defect 4

Infiltration: ☐ None ☐ Joint ☐ Cracks ☐ Mortar ☐ Roots ☒ **Wall**

there is infiltration between the pipe & the wall

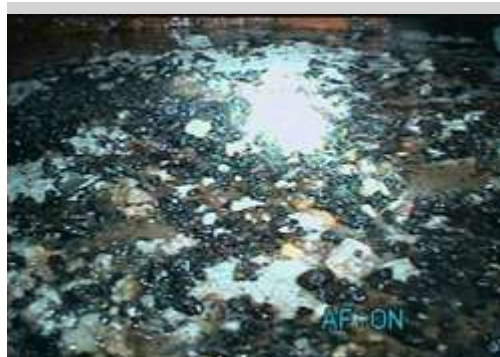
Defect 3

Condition: ☐ Sound ☐ Cracked ☐ Root Intrusion ☐ Deteriorated ☐ Leaks ☒ **Debris**

bench debris

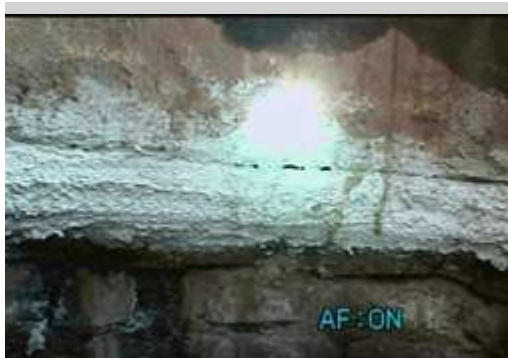
Defect 2

Condition: ☐ Sound ☒ **Cracked** ☐ Root Intrusion ☐ Loose Brick ☐ Deteriorated

chimney cracked, frame adj

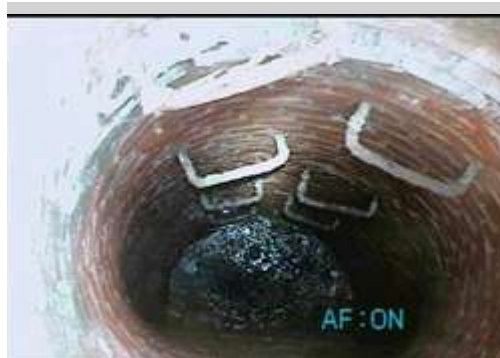
Defect 1

Count: **8** Missing: **0** ☒ **Corroded**

steps

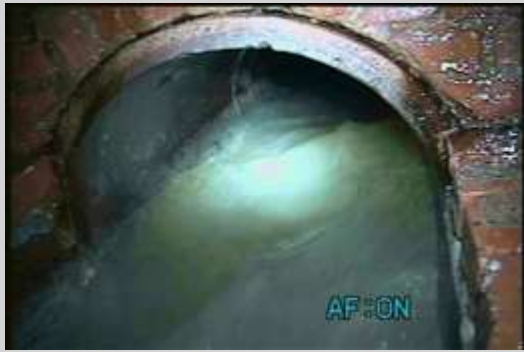
6 O'Clock Inflow

Infiltration: **Runner** Pipe Seal Cond: **Cracked**
